AN INVESTIGATION
OF
FIRE RETARDANT CAUSED CORROSION

UNITED STATES DEPARTMENT OF AGRICULTURE
FOREST SERVICE
INTERMOUNTAIN FOREST & RANGE EXPERIMENT STATION

**FINAL REPORT
BY
G. A. Gehring Jr.**

30 September 1974

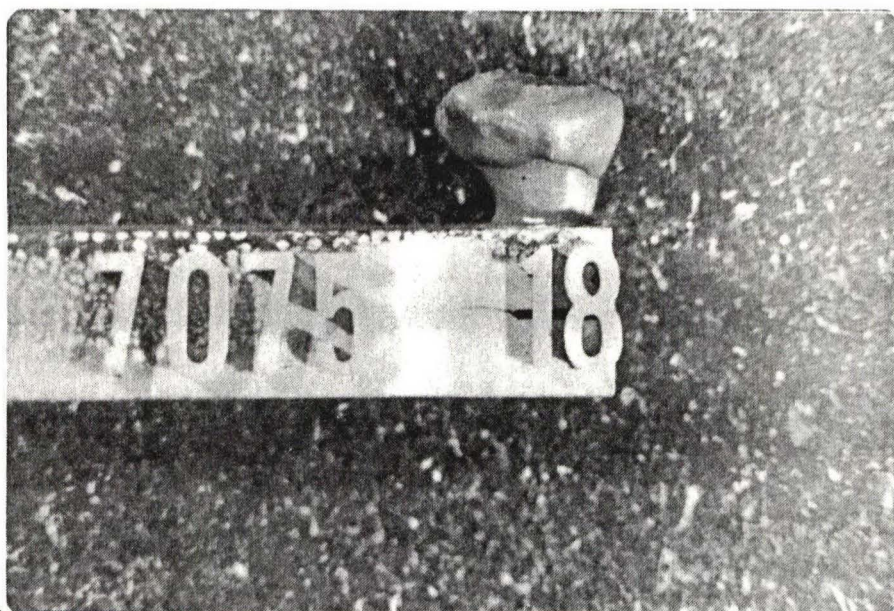
Figure 26 - DCB Specimen After Exposure to
Fire Retardant

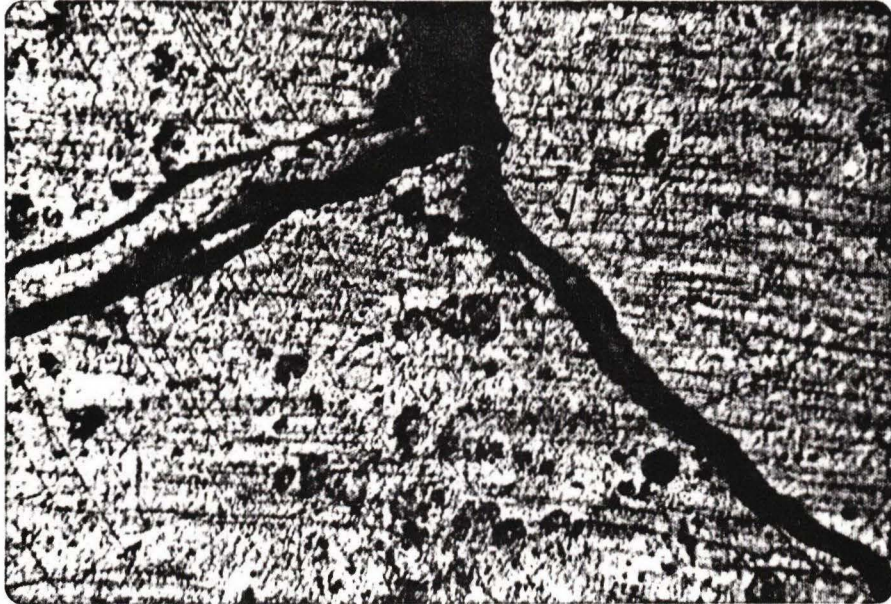
Figure 31 - DCB Specimen After Exposure to
Fire Retardant
